SERVICE BULLETIN

Classification: BT02-031	Reference: NTB02-122	Date: December 11, 2002
-----------------------------	-------------------------	----------------------------

2003 350Z; INTERIOR SQUEAK AND RATTLE REPAIR

APPLIED VEHICLE: 2003 350Z (Z33)

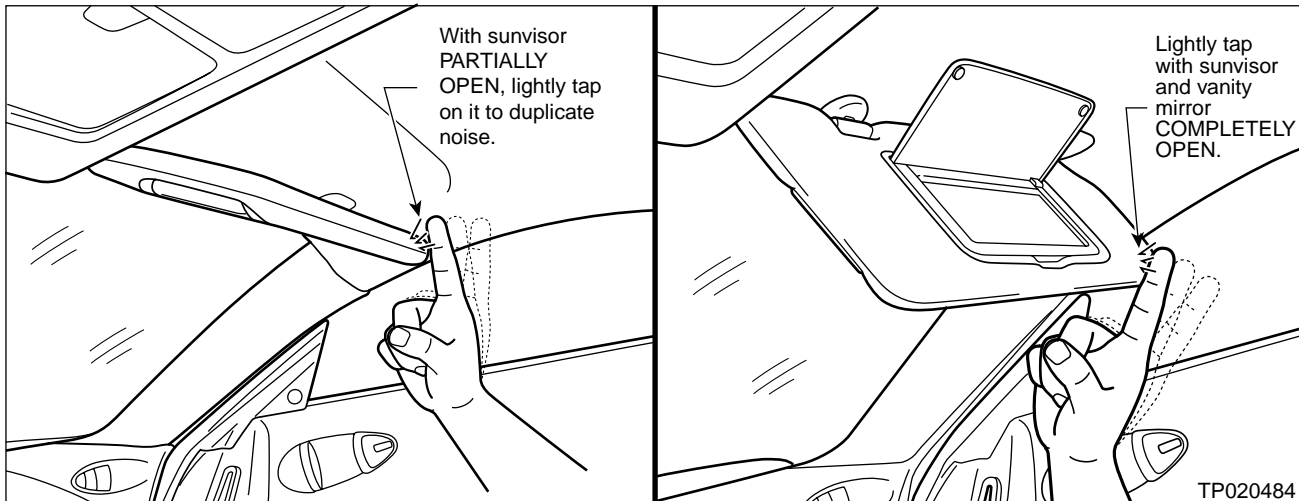
1) Light “wine glass ping”/high-frequency metallic noise from the center upper windshield of vehicle.

1. With the sunvisor in the PARTIALLY OPEN position, lightly tap on the sunvisor to duplicate the noise (see Figure 1A).
2. With the sunvisor and vanity mirror in the COMPLETELY OPEN position (with the vanity mirror light turned “on”), lightly tap on the sunvisor again (see Figure 1B). If the noise is no longer present, proceed to the Repair section, below.

1. Replace the original sunvisor vanity mirror light bulb and lens with a replacement bulb and lens (see Figure 2). See the PARTS INFORMATION section for detail:
 - A. Insert a thin screwdriver in the lens end and remove the lens.
 - B. Remove the vanity mirror light bulb (vanity mirror lamp: 12V - 1.32W).
 - C. Install the replacement bulb.
 - D. Install the replacement lens.

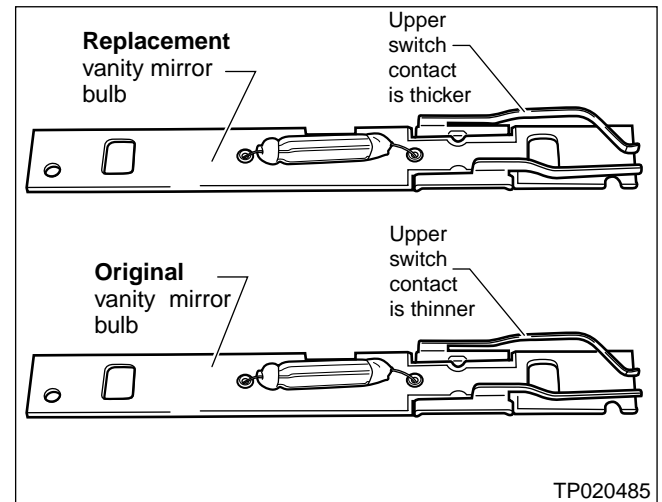
Figure 3

NOTE: The upper switch contact has been increased in thickness on the replacement bulb. See Figure 3.

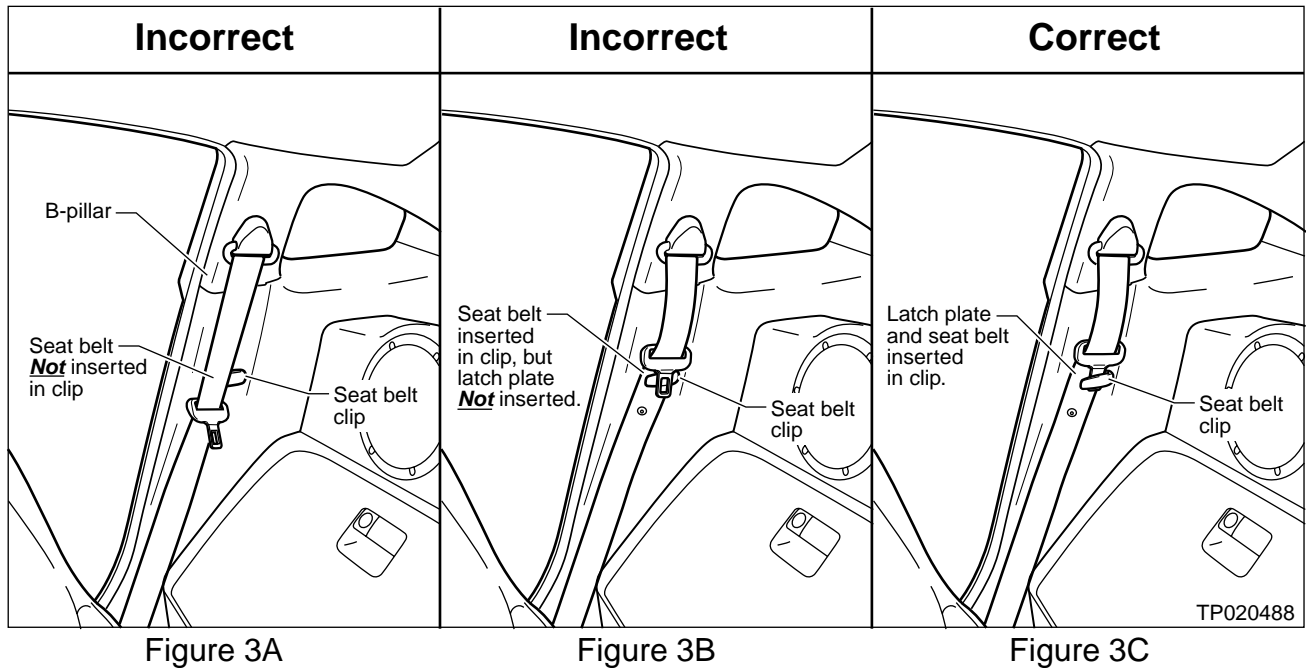
2) Hollow rattle from passenger side of vehicle.

This noise may be caused by contact between the passenger-side seat belt latch plate and the B-pillar.

NOTE: If the seat belt and latch plate **are not completely and properly inserted into the seat belt clip**, the rattle will not be eliminated. See Figures 3A and 3B for examples of incorrectly inserted seat belt/latch plate.

1. Examine the passenger-side seat belt to see how it is secured.
2. Insert both the latch plate **and** the seat belt into the seat belt clip. This is located on the passenger-side B-pillar (see Figure 3C).
